**RAMADI 132-KILOVOLT SUBSTATION
RAMADI, IRAQ**

**SIGIR PA-08-153
JANUARY 27, 2009**

Ramadi 132-Kilovolt Substation

SUBJECT: Report on Ramadi 132-Kilovolt Substation in Ramadi, Iraq
(SIGIR Report Number PA-08-153)

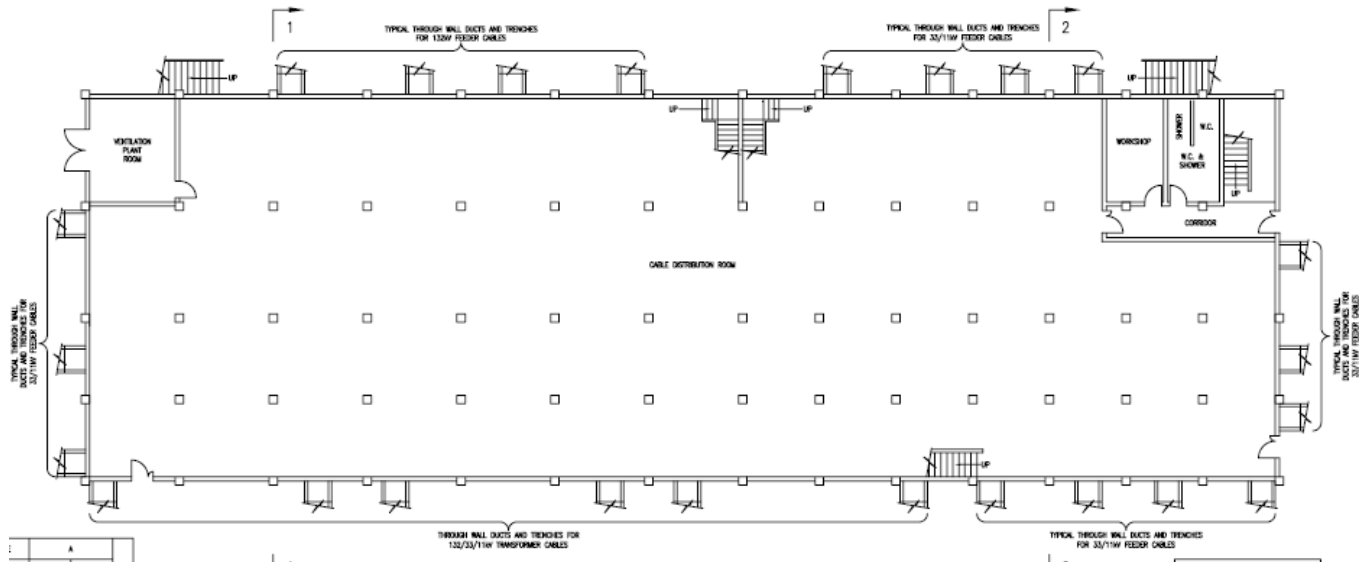
Figure 3. Substation building – ground floor (Courtesy of USACE)

In addition, the interior of the substation building appeared to be well constructed (Site Photo 5). The ground floor design shows the columns required to support the heavy loads from the first floor's electrical equipment (Figure 3). During the site assessment, the inspectors observed that the ground floor columns were painted and there did not appear to be any patches. There were no obvious signs of cold joints, honeycombing, or steel exposure. The contractor had properly aligned and connected the elevated cable trays to the substation structure (Site Photo 6).

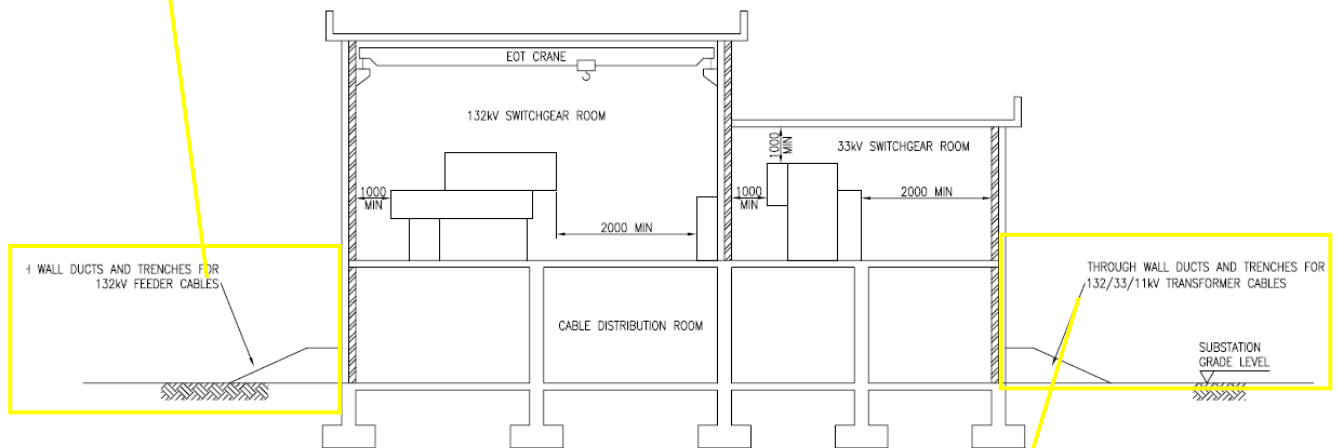
Figure 4. Side view of cable trenches (Courtesy of USACE)

The design required through-wall ducts and trenches for 132-kV feeder cables, 132/33/11 transformer cables, 33-kV feeder cables, and 11-kV feeder cables (Figure 4). The concrete cable trenches appeared to be well constructed and monolithic (Site Photo 7). For the wet season, the interior of the cable trenches has French drains (Site Photo 8). The cable trench proceeds up to the building (Site Photo 9), and the exterior wall of the substation has conduit installed to allow for the passage of cables from the transformer cables to enter the interior of the substation and for the feeder cables to exit the building (Site Photo 10).

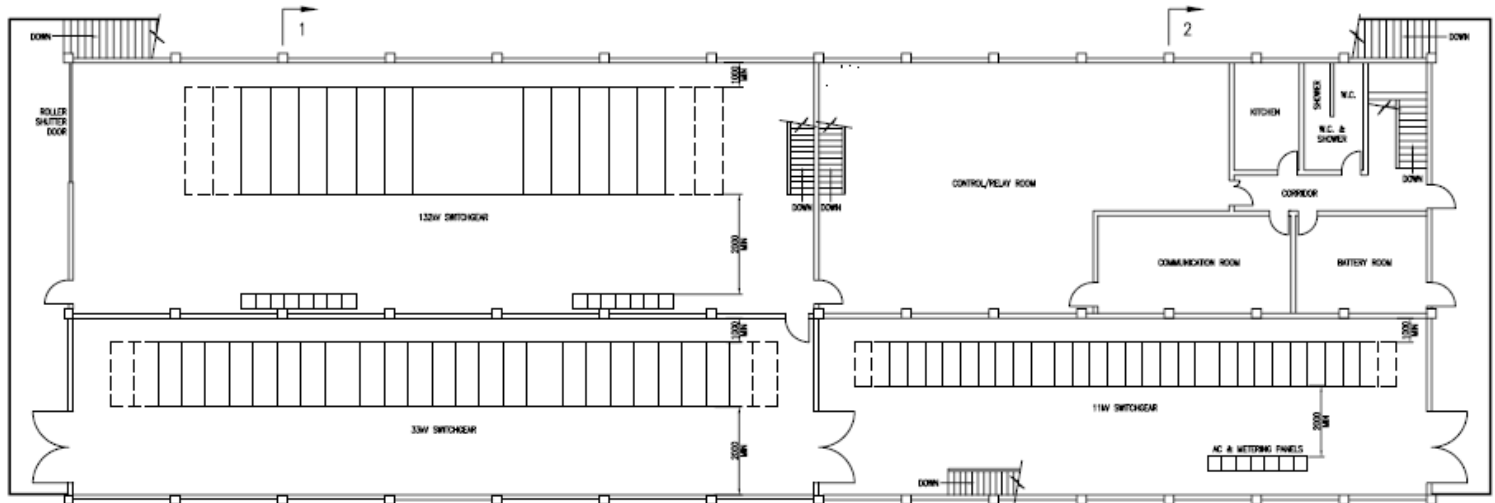
Figure 5. Substation building – first floor (Courtesy of USACE)

The design required the first floor of the substation building to have five main areas. Main areas of the first floor include the 132-kV switchgear room, 33-kV switchgear room, control/relay room, communication and battery room, and 11-kV switchgear room (Figure 5). During the site assessment, a majority of the switching equipment was not completely installed, and the GIS was still in the original plastic wrapping (Site Photo 11). The site assessment team observed that the Gantry crane was installed, but not operational (Site Photo 12). The contractor stated that the electrical equipment required complete assembly before Site Acceptance testing could be performed. Until repaired or a work around solution is found, the damaged GIS units are preventing complete installation and testing.

1. Continue efforts to expedite repair of the gas-insulated switchgear.
2. Require the contractor to provide the 90% design submittals.

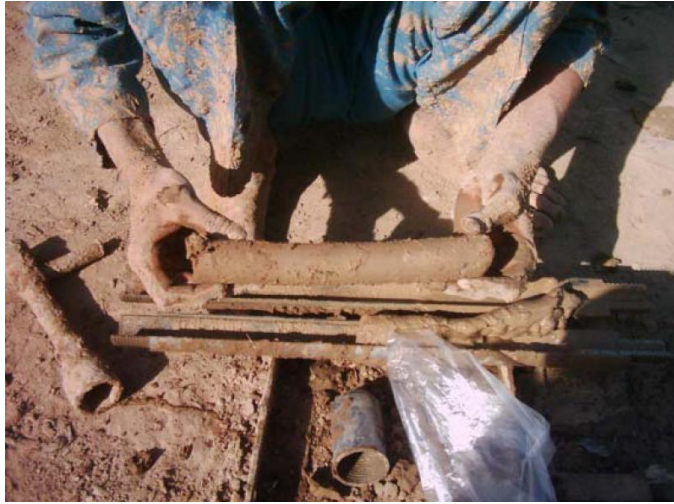
Site Photo 21. Split spoon sample (Courtesy of USACE)

Throughout the project, the contractor conducted daily, weekly, and monthly meetings to review applicable specifications, drawings, submittals, and testing before the start of definable activity on the project. The contractor maintained QC reports, which included descriptions of the day's activities and work performed, workers present, major equipment present, weather conditions, and significant events or concerns for the areas of the Ramadi 132-kV Substation project. In addition, the QC reports had records of tests, inspections, re-work, or deficiencies identified throughout the day. For example, the QC report, dated 15 February 2007, showed the soil investigation tests being conducted (Site Photo 21). In addition, the contractor provided the borehole results for the soil investigation. However, the contractor did not record the results of all concrete or cable tests taken, both passing

and failing, on the QC reports for the dates taken. There is no mention, on the few test results provided, the location where the tests were taken and the sequential control number identifying the test.
